**STRESS CORROSION TESTING OF SA 455 CARBON STEEL IN
METH-REACTION INHIBITED AGRICULTURAL AMMONIA SOLUTIONS**

PREPARED FOR
IOWA DEPARTMENT OF TRANSPORTATION
DES MOINES, IOWA

PREPARED BY
CC TECHNOLOGIES LABORATORIES, INC.
MICHEL P. H. BRONGERS, P.E.
WILLIAM KOVACS III
JOHN A. BEAVERS, Ph.D.
ARUN K. AGRAWAL, Ph.D.

AUGUST 30, 2006

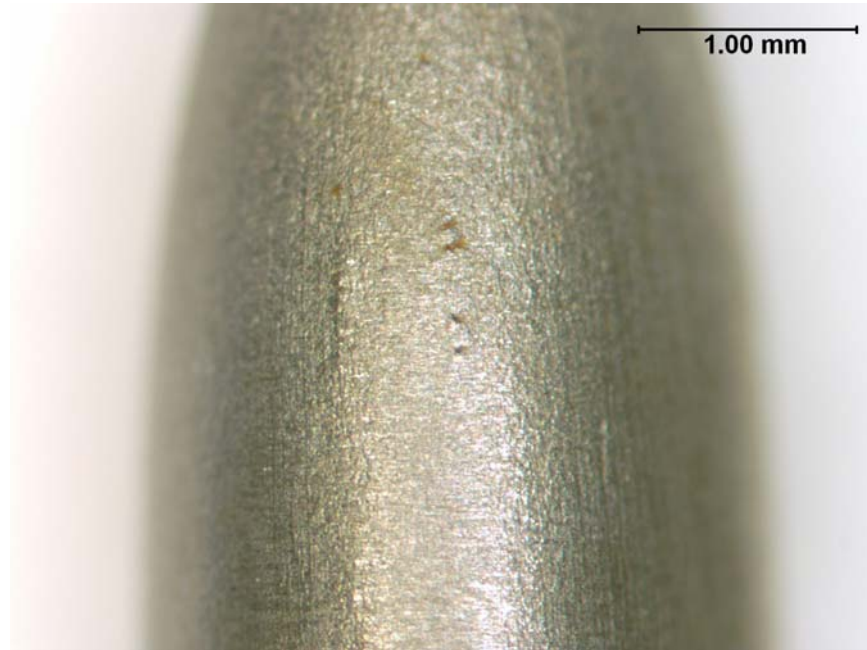
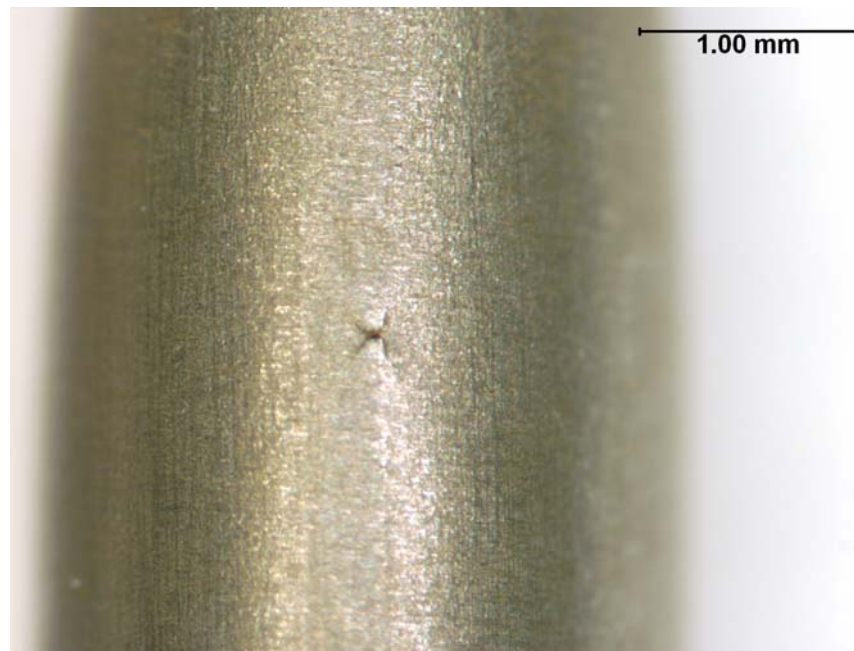
Figure 15. Stereo-photomicrographs of gage section near fracture surface of specimen from Test 17 showing small surface fissures.

At higher magnifications, small surface fissures were revealed on the specimens from Tests 14, 17, and 12, as shown in Figures 14, 15, and 16, respectively. For these specimens, the longitudinal cross-sections were prepared by cutting through these features. For all other specimens, no notable surface features were visible and a random longitudinal cross-section was made halfway through the gage thickness.

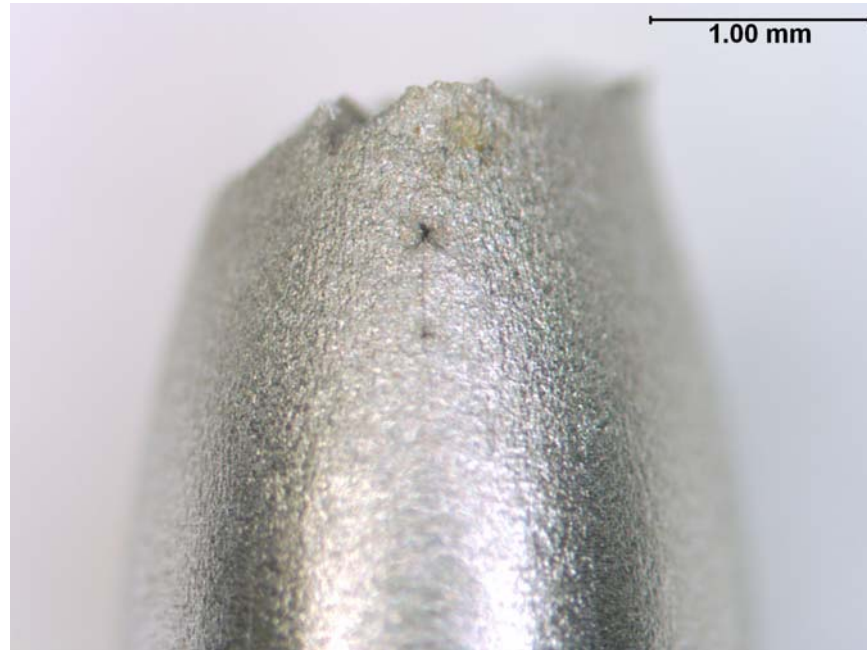
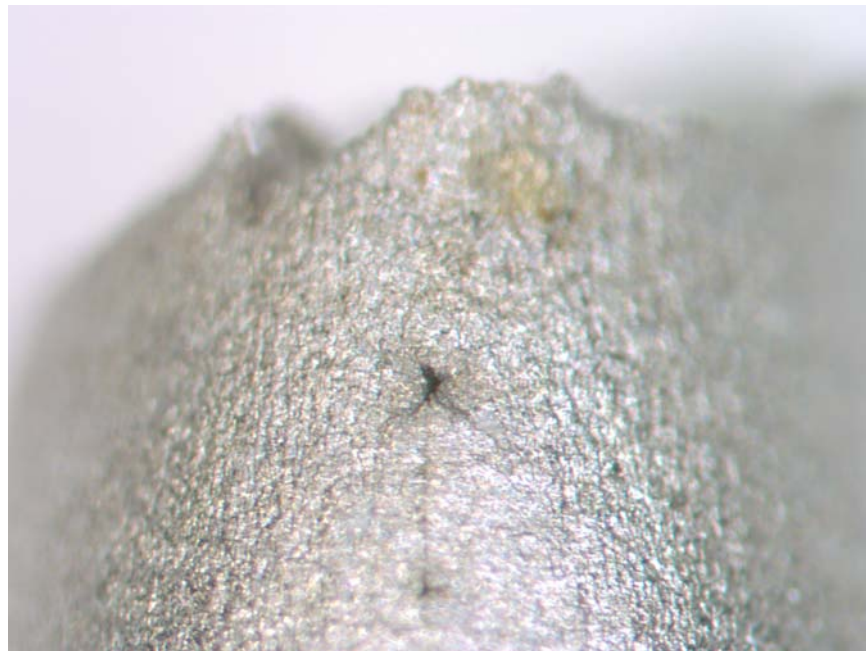
Figure 16. Stereo-photomicrographs of gage section near fracture surface of specimen from Test 12 showing small surface fissures.

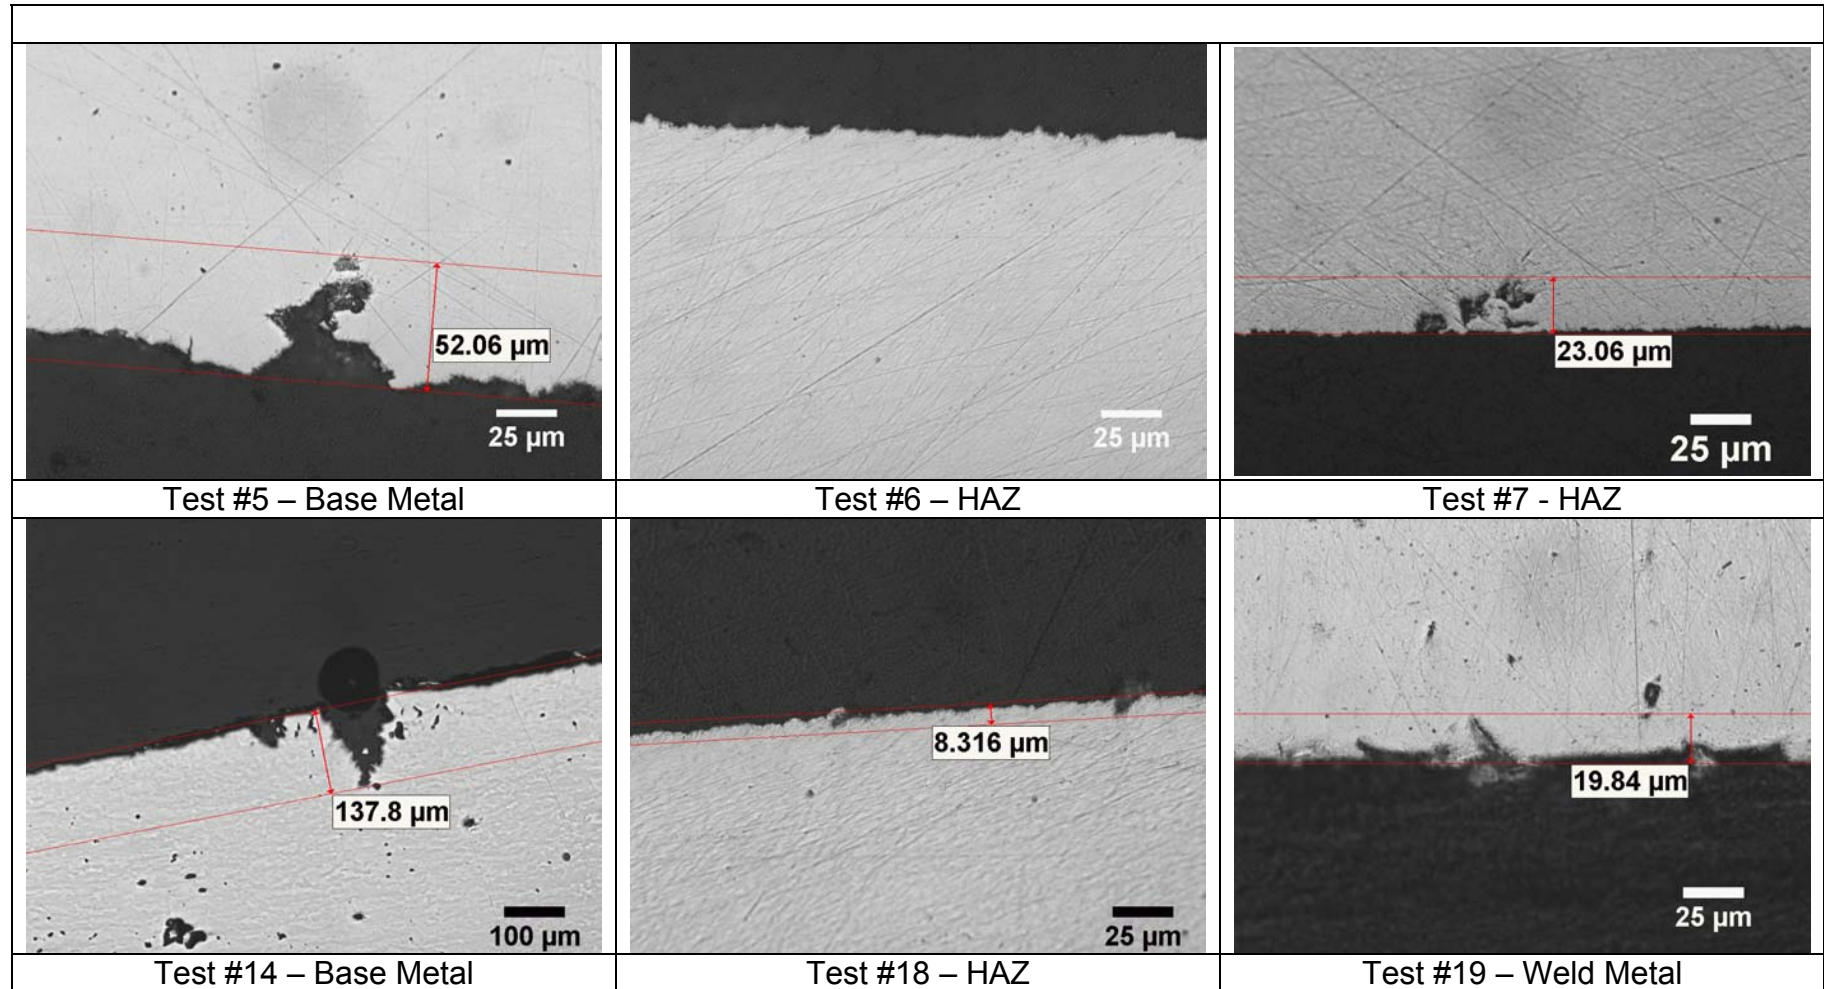
Figure 17b. Photomicrographs showing the deepest surface fissures in gage sections of specimens tested in anhydrous ammonia + 2% $\text{Ca}(\text{NO}_3)_2$.

Figures 17a-c present photomicrographs of the deepest surface fissures in the cross-sections of the various gage sections. The measurement of the maximum penetration depth is also shown in these photomicrographs. The specimens from Tests 17, 5, 14, and 12 likely experienced SCC. The cracks were present in 3 base metal specimens (anhydrous ammonia and anhydrous ammonia + $\text{Ca}(\text{NO}_3)_2$) and in 1 HAZ specimen (anhydrous ammonia + $\text{Ca}(\text{NO}_3)_2$ + N-Serve®). The cracks encompassed multiple grains and ranged in depth between 50-1100 μm . The etched microstructure at the cracks showed that the cracks were intergranular in nature, consistent with ammonia SCC. All other penetrations were possibly incipient cracks. The incipient cracks (ten specimens) generally encompassed two grains or less, and had depth < 50 μm . No significant surface features were found in the remaining four specimens.

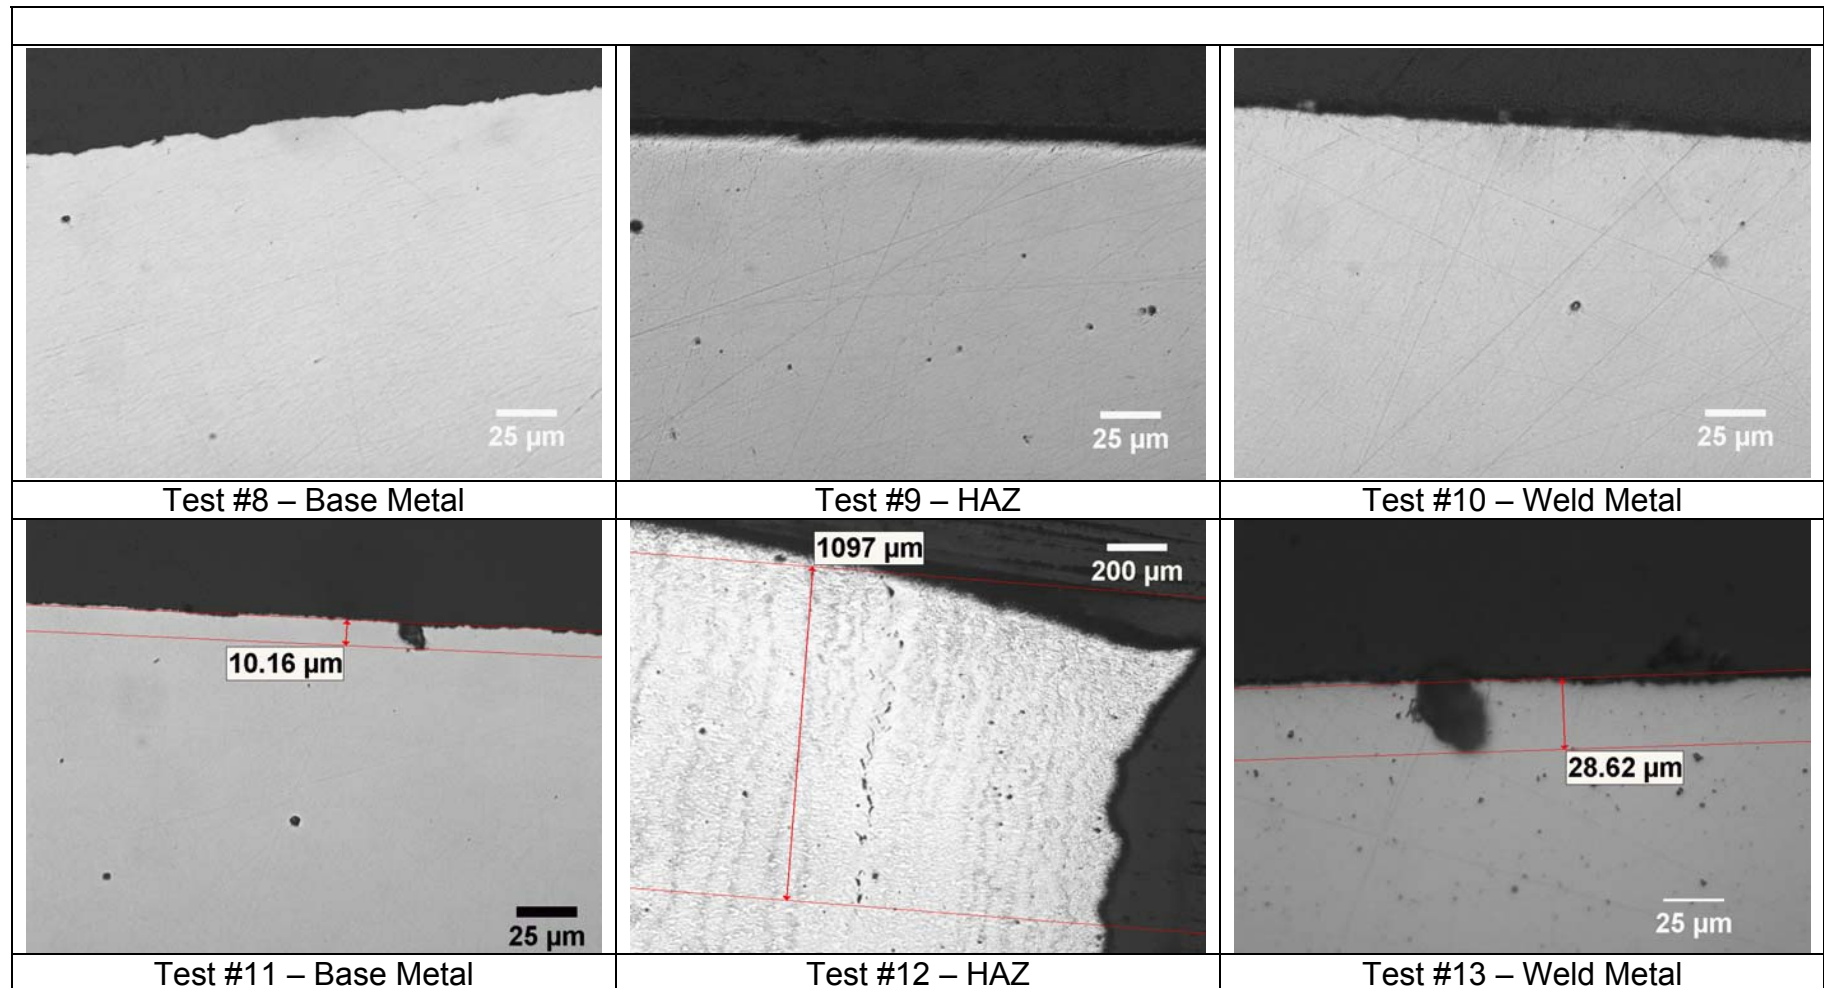
Figure 17c. Photomicrographs showing the deepest surface fissures in gage sections of specimens tested in anhydrous ammonia + 2% $\text{Ca}(\text{NO}_3)_2$ + N-Serve®.

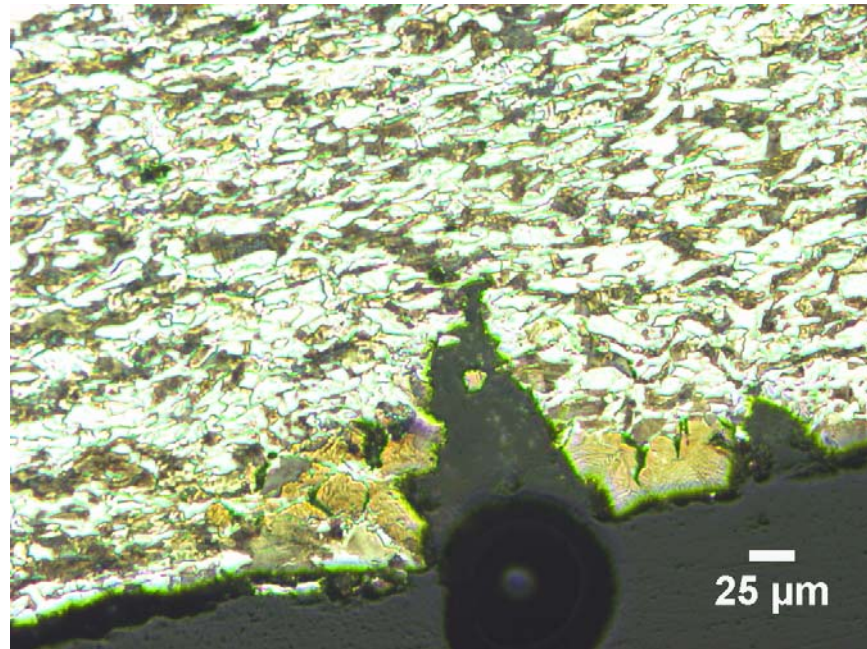
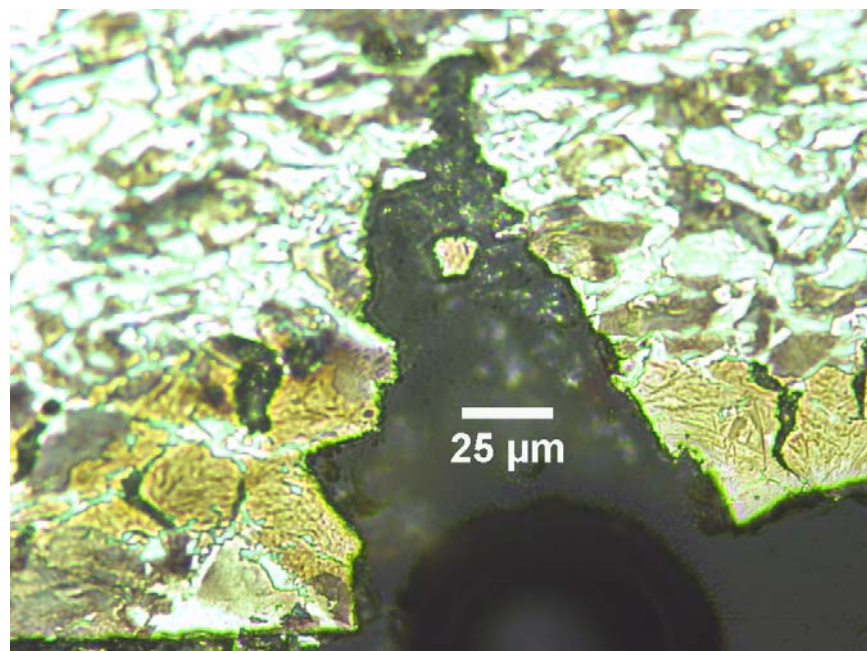
Figure 18. Photomicrographs of cross-section of gage section of specimen from Test 14 showing secondary cracks; Nital etched.

Figures 18, 19, and 20 show additional photomicrographs of cross-sections for the specimens with the deepest cracks (Tests 14, 17, and 12). It was noticed that, in addition to the ferrite and pearlite in the banded microstructure, another phase was present at the locations where cracks were present. This phase appeared light-brown after Nital etching, while the ferrite was light (white) and the pearlite dark (black). Knoop micro-hardness (HK) measurements were taken to distinguish it from its surroundings. Indeed, the hardness of the brown phase was 362 HK, while the pearlite gave readings in the range of 180-290 HK, and the ferrite was 220-270 HK. Thus, the distinct phase may have been martensite – a hard phase that may be present as a remnant of the steel plate's manufacturing process. The cracking appeared to have occurred preferentially within this phase, as multiple parallel cracks were confined inside the distinct phase in each of these three specimens. The base metal microstructure of ferrite/pearlite was found not to be affected by SCC in these same specimens.

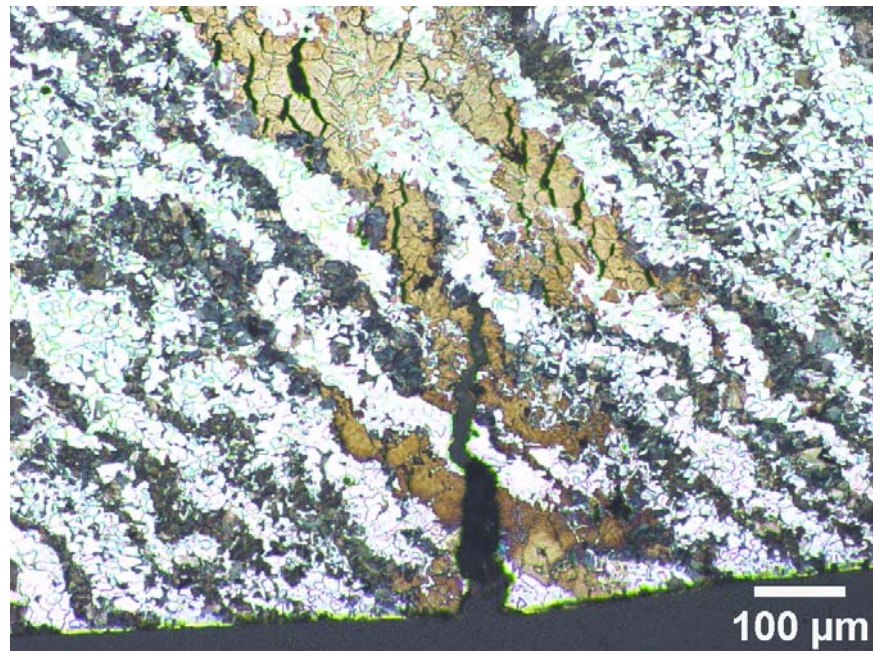
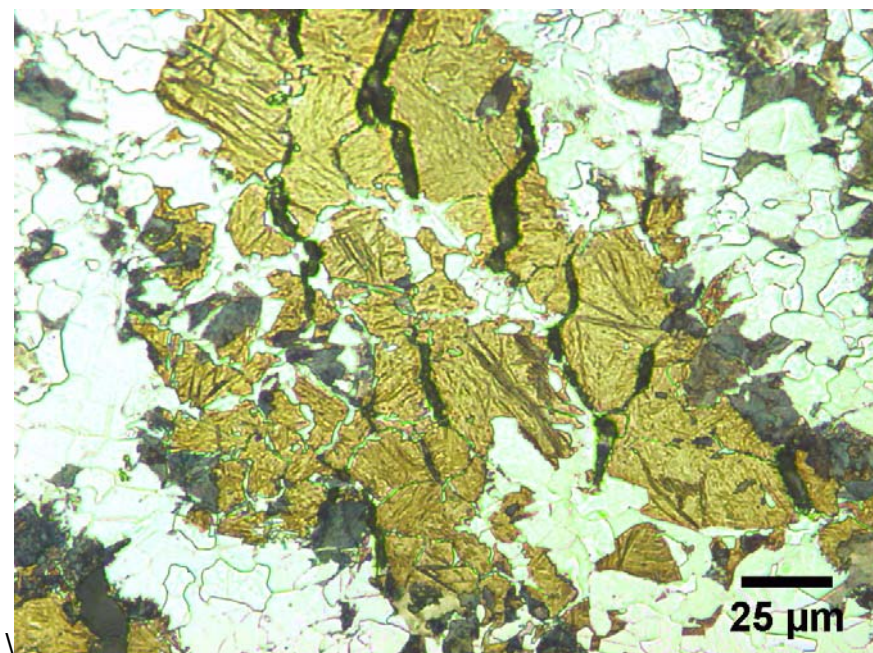
Figure 19. Photomicrographs of cross-section of gage section of specimen from Test 17 showing secondary cracks; Nital etched.

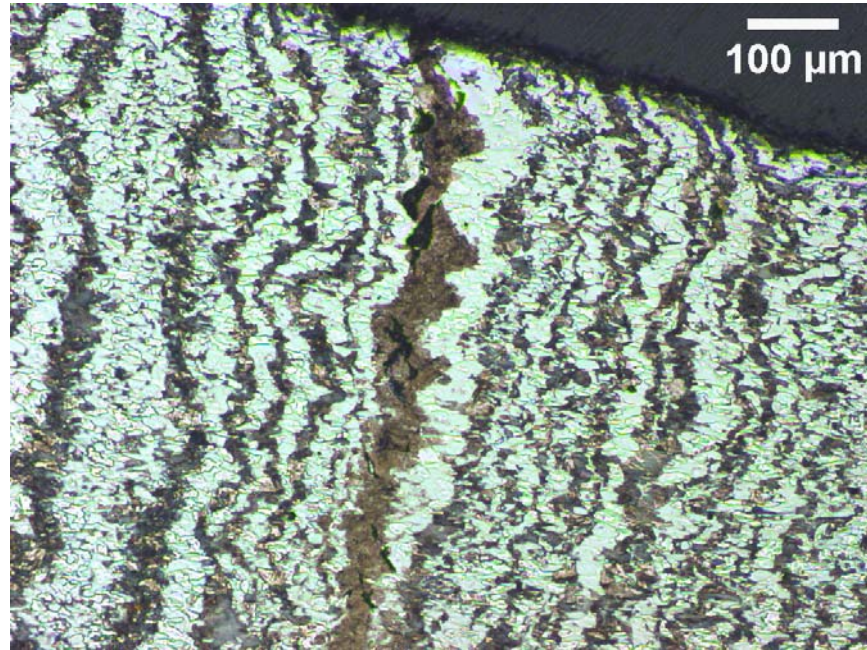
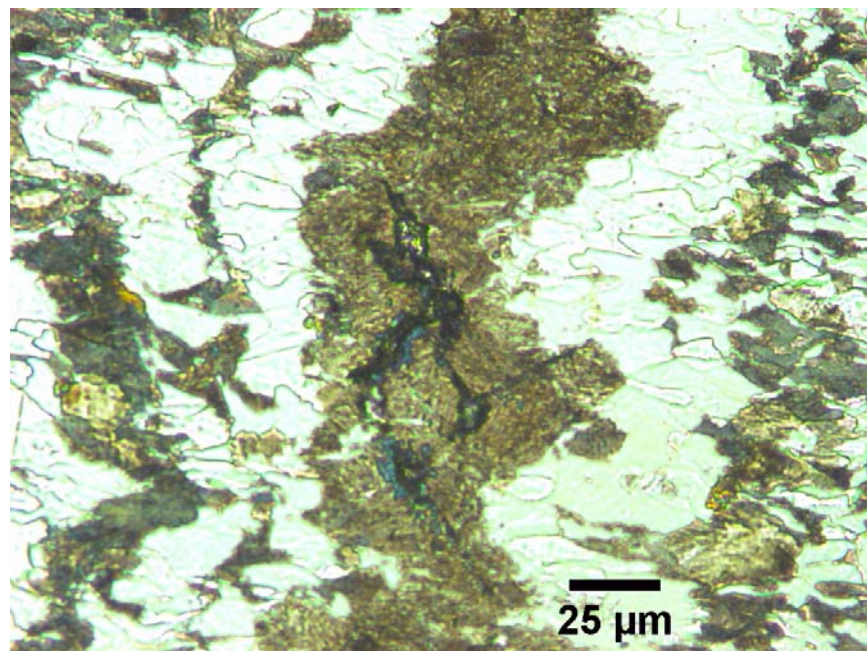
Figure 20. Photomicrographs of cross-section of gage section of specimen from Test 12 showing secondary cracks; Nital etched.

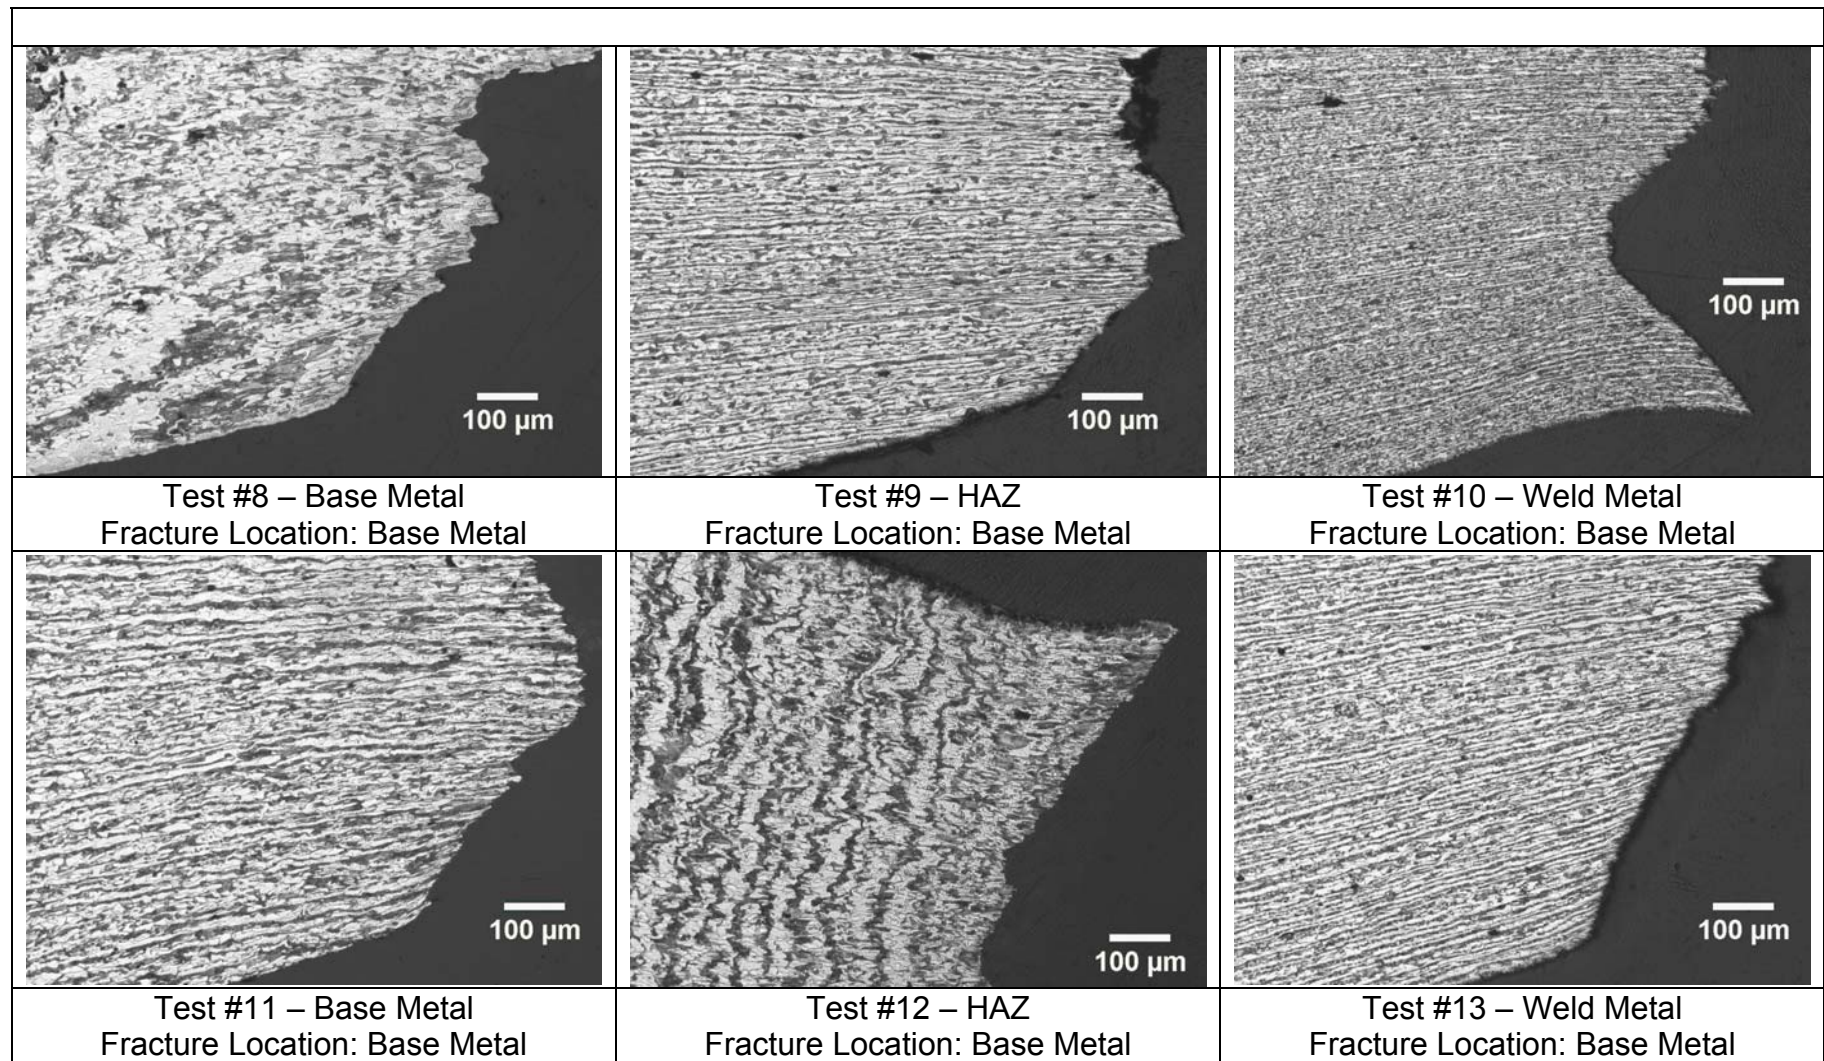
Figure 21c. Photomicrographs showing the grain structure of specimens near the fracture location, in anhydrous ammonia + 2% $\text{Ca}(\text{NO}_3)_2$ + N-Serve®; Nital etched.

Figures 21a – Figures 21c present photomicrographs showing the microstructure around the fracture area, to identify the location of the fracture relative to the weld and HAZ in each specimen. The figures demonstrate that the fracture location for each specimen was in the base metal, except Test 2. Test 2 was conducted on a weld metal

specimen in anhydrous ammonia, and the specimen failed at the weld center. The fact that all but one specimen failed in the base metal showed that under the test conditions, the weld fusion metal and HAZ did not have increased SCC susceptibility, as compared with the base metal.
